Engineering Bulletin #105 Encoder Faults

O. Thompson Co.

Slowdown Failure Fault

Encoder Sensor Failure, Excess Deviation Faults

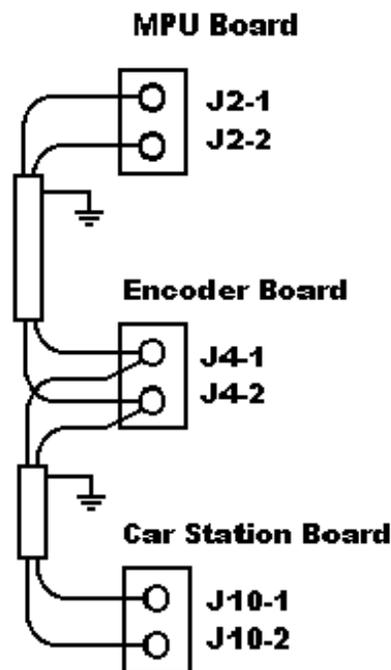
We recently found several locations where Encoder Sensor Failure and Encoder Excess Deviation were occurring. Replacing the Encoder PC board, the Sensor board, and the Sensor cable did not correct the problem. What was found was that the LON network was not connected properly. In all cases, the network was run to a terminal strip on the car, and from the terminal strip it was then routed to the Intelligent Car Station board and

the Encoder board, creating two network 'branches.' This is not desirable, as network communication will not properly occur. The correct method of connecting the network is to route it from the controller MPU board to the Encoder board. The shield on the cable should be grounded on the controller side, and left disconnected at the Encoder. The network should then be wired to the Intelligent Car Station board. This cable should have its shield connected only at the Car Station board end. Please refer to the diagram below.
