Engineering Bulletin #113 Failures on 3-Pole Plug-in Relays on Tricon Controllers

O. Thompson Co.

Tricon Plug-in Relay Failures

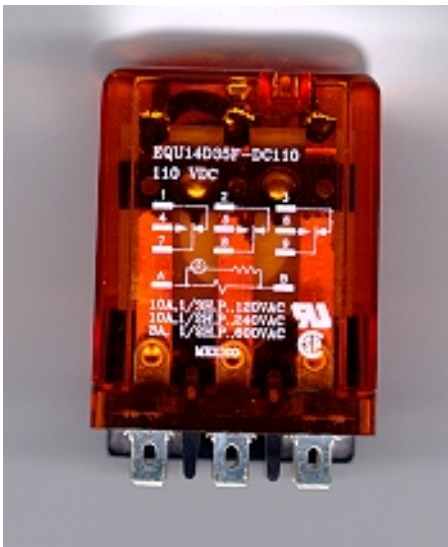
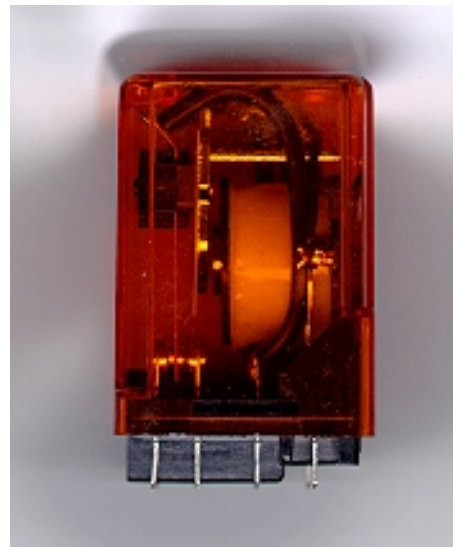
O. Thompson has experienced an unacceptable rate of failure on the 3-pole plug-in relays on the Relay Board of Tricon car controllers. The effected relays carry part number **EQU14D35F-DC110**. Not all relays with this number are effected, though. To determine if the relay needs to be replaced, look at the coil inside the relay. If the coil is white, the relay should be replaced. If the coil is black, the relay will work properly and does not need to be replaced. See the pictures below for identification of the effected relays.

O. Thompson will supply new relays at no charge to replace the existing relays. To order the replacement parts, please contact O. Thompson Technical Support at (718) 417-3131.
