Engineering Bulletin #114 Wiring Change for Magnetek DSD412 SCR Drives on Tricon Controllers

O. Thompson Co.

Released 12/20/01

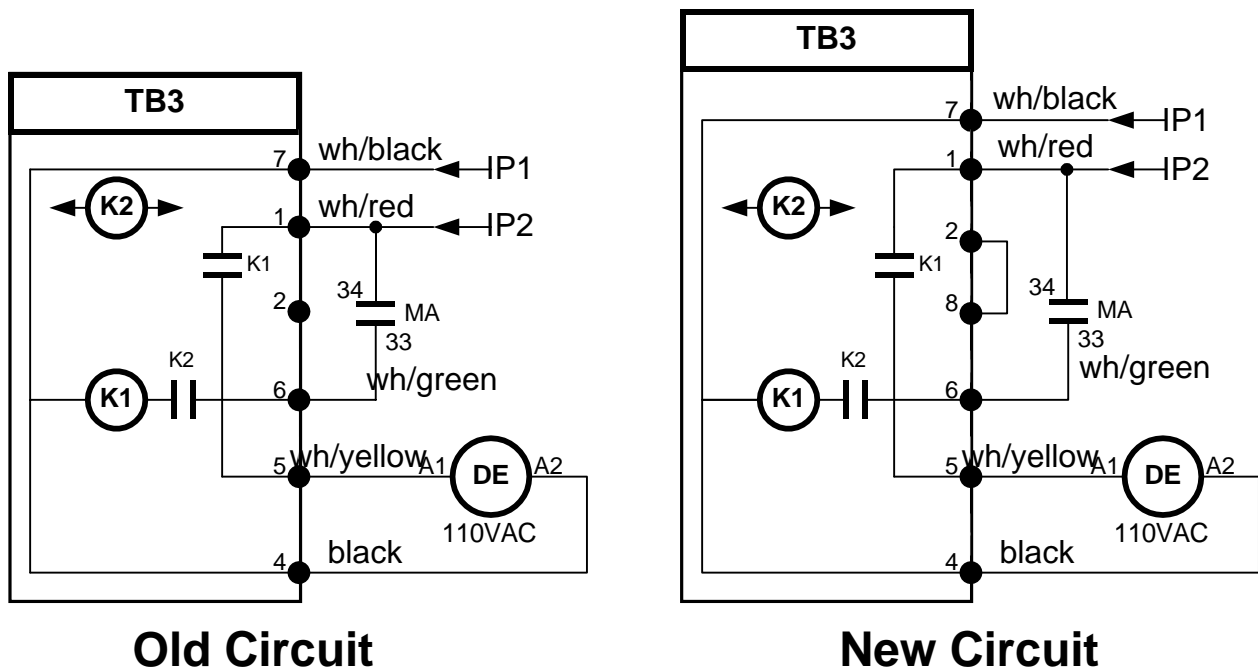
We have recently found that Tricon controllers using the Magnetek DSD 412 SCR drive are not enunciating all faults to the controller processor. This condition could result in the drive being shut down and the controller processor not knowing it. To correct this, a minor wiring change is required. This change should take about five to ten minutes to perform on each controller, and the only material required is 3 short (about 4") pieces of wire.

First, remove power from the controller. Looking at the front of the drive you will see wiring coming to the left side of the drive near the top. This wiring is adjacent to the drive display. This connector to the drive is TB3. Remove it by pulling it straight out. Install a jumper from TB3-2 to TB3-8. **Please note that the bottom terminal on this connector is pin 1.** After installing the jumper, plug the connector back into the drive. Refer to the diagrams below:
